FACILITY CONDITION

ASSESSMENT

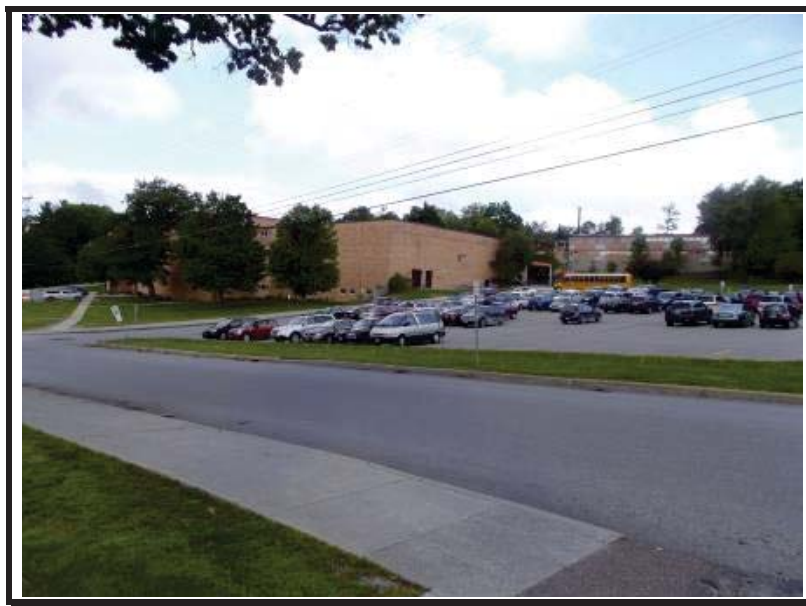
FACILITY CONDITION ASSESSMENT

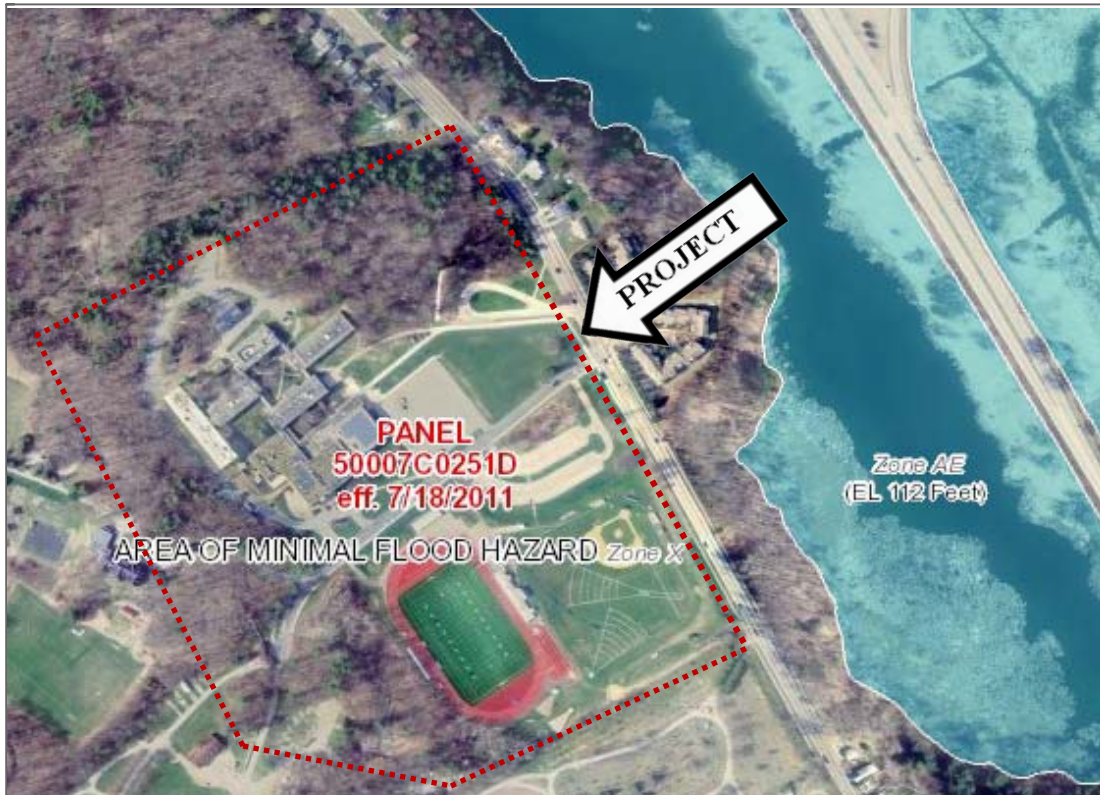
DigitalGlobe, GeoEye, Microsoft, VCGI, USDA FSA, CNES/AirbuD
